# **Impact Characterization of Fiber/Foam Reinforced Polymer Nanocomposites**

*Abstract--Synthetic foam is light weight engineered foam which is incorporated in polymer matrix. The synthetic foam structure gives several advantages such as low density, high strength and low co-efficient of moisture absorption. It also possess good amount of tailor ability and can be casted into intricate shape. In this study, sandwich panels were fabricated with syntactic foam and 4-layered woven roving glass fiber/epoxy nanoclay composite laminates. The nanocomposites laminates were prepared by varying the nanoclay at a loading of 0, 1,2,3,4% by weight. The structure of the prepared nanocomposites is characterized by Scanning Electron Microscope (SEM) to find the quality of dispersion. High velocity gas gun impact test had been conducted at the velocity 130m/s. From the impact test the fracture surface area had been calculated. The impact surfaces were analyzed using SEM. The SEM image clearly showed a good interface bonding with fibre and synthetic foams when addition of nanoclay. So the better interface bonding reduces the damaged area.*

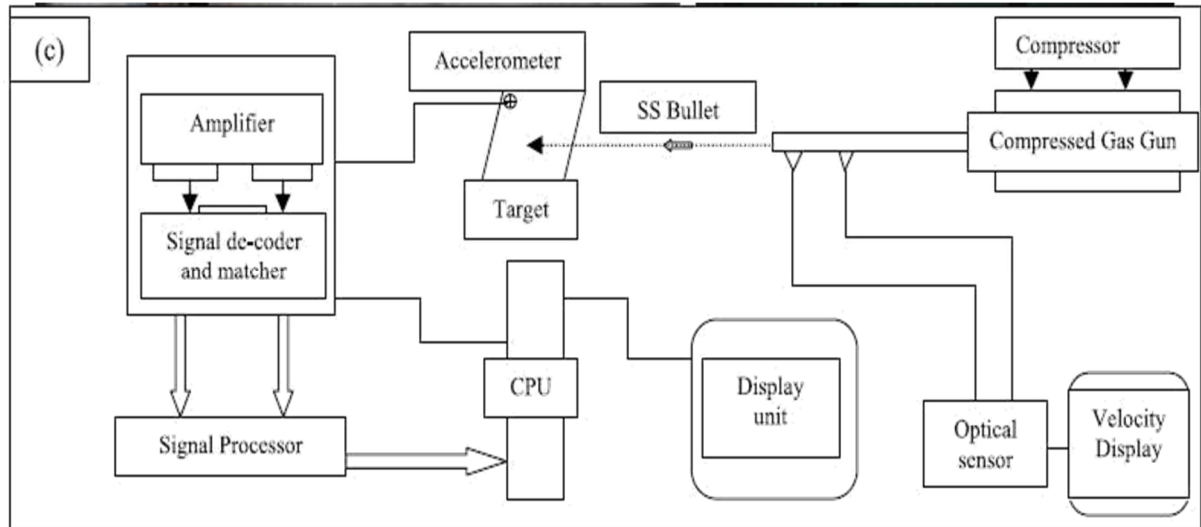
Fig.2 Actual test set-up (a), the target holder (b), and the schematic (c).

An attempt was made to explore some of the simplest experimental ways of assessing the impact response and vibration damping characteristics of a material, in particular, GF/Al/Nanoclay/epoxy resin laminate panels, due to their importance on the subject of damage detection and modelling. ASTM E 756-04, standard test method, was referred for determining impact vibration damping characteristics of fiber reinforced hybrid nano-composite panels. This standard measures the damping properties such as loss factor ( $\eta$ ) and Young's modulus 'E' or shear modulus 'G'. Composite laminate is a viscoelastic material, hence, viscoelastic damping, most common form of damping employed to solve noise and vibration related problems. It is a passive-based material (or viscoelastic) damping, usually in the form of add on treatments applied to a structure. The actual test set-up is shown in Fig.2 (a) whereas the schematic set-up is shown in Fig.2 (c). Meaningfully, the system comprises a powerful compressed gas gun, target holder, data acquisition system (DAS) and display units for measuring the time response of impacted panel vibration and velocity of the bullet. The DAS comprises signal processor, de-coder and matcher and amplifier along with optical velocity pick up. The panels ( $150 \text{ mm} \times 150 \text{ mm}$ ) were fixed vertically in the target holder (fixture) by nuts and bolts in all the four sides as shown in Fig16 (b). The accelerometer KS80D weighing 70 g was fixed to the plate in the slot provided at the top right corner with the help of nut to measure the time response. The National Instruments Data Acquisition System (DAS) was used to pick up the dynamic parameters.

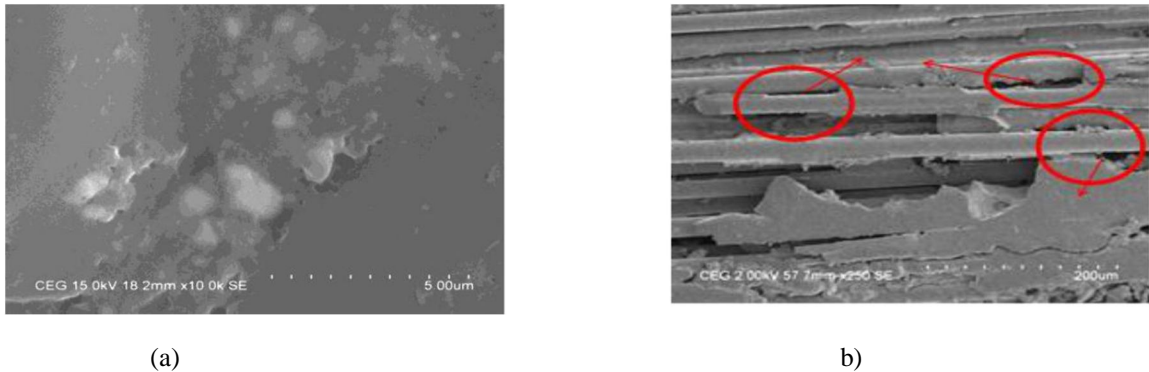
Fig.4 Structural morphology of (a) 3wt % of nanoclay in epoxy resin and surfaces of (b) 4wt % of nanoclay laminates.

The SEM technique was used to investigate the surface morphologies of the prepared samples. The surface morphologies of the nanoclay, the fabricated polymer nanocomposite laminates were examined under scanning electron microscope of model HITACHI S3400N. The structure of the 3wt % of nanoclay mixed with epoxy resin was shown in fig.3 and detailed a massive layered structure with some large flakes and some inter layer spaces. It is observed that uniform bonding and dispersion of nanoclay powder in the epoxy resin. This interfacial bonding structure improves the adhesive property between fiber and the syntactic foam

From fig. 3(b) the formation of voids and the pullout of fibers were observed at 4wt % of nanoclay in the laminates. This is due to improper bonding between the filler and reinforcement materials. This type of surfaces provides interline failures on the laminates when the load applied on it. To avoid this type of formations proper mixing and uniform dispersion of filler materials in the resin was carried out. At 4wt % of nanoclay powder, due to less amount of filler content and minimized surface area distribution on the matrix face the formation of voids and pullout of fibers where observed.

The SEM images obtained from the (3wt %) region that nanoclay were uniformly dispersed with the epoxy resin.

The surface failures of 1wt % of nanoclay mixed laminate detailed about the formation of voids and pullout of fibers due to less dispersion and improper bonding.

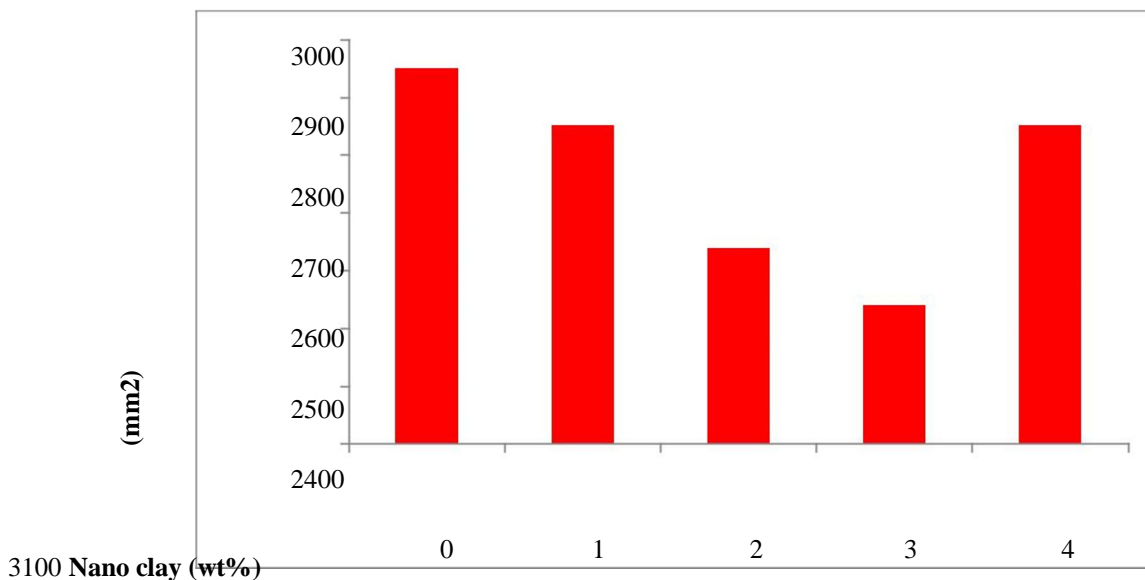
Fig. 6 Area of front surface fracture

From the Fig 6 it shows the front surface damage area had been controlled for the laminates with 3% nanoclay but for the laminates with 4% nanoclay the damaged area had been increased. From the Fig.7, shows the back surface damage area. Similar to front surface the back surface also the 3% laminates are showing the failure area had been controlled. The nanoclay samples penetration did not occur on the back face and the modes of failure were a combination of matrix cracking and surface splitting as represented in Fig.7 (b) and (c).

The fracture area was controlled by the addition of nanoclay and 3 wt% clay nanocomposite was less when compared with other laminates.

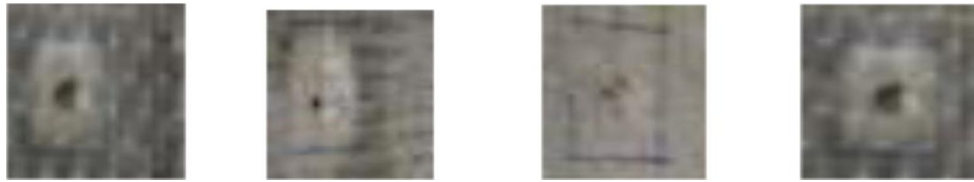
Fig.7 Fractography of back face at 130m/s (a) neat, (b) 1 wt%, (c) 3 wt% and (d) 4wt% nanoclay samples

The damage on the front face was similar for all the samples, a circular indentation or round damage was recognized. The failure modes on these specimens are shown in Figure 5. The damage on the front face was similar for all the samples, a circular indentation or round damage was recognized. The failure modes on these specimens are shown in Fig 5. For the laminate impacted at 130m/s by a cylindrical impactor, there was extensive damage in the front face consisting of fibre breakage, penetration and delamination, and also propagation of surface crack. As seen from the image of damaged nanocomposites samples in Fig 5 (b) and (c), the failure mechanisms were surface cracks and minor matrix cracking. The Fractography of the back faces of the damaged nanocomposites samples as illustrated in Fig 6. It was observed that although neat epoxy sample survived extensive damages, it also gave into matrix cracking, delamination and surface splitting as in Figure 7 (a). The delamination area had expanded due to the weak interfacial bonding between fibre and matrix. However, the damage modes of the nanoclay samples involved a combination of matrix cracking and surface splitting as represented in Fig 7 (b) and (c).

From the image of damaged 3 wt% sample (Fig7 (b)), it was observed that glass fibers adhered completely with the resin due to good interfacial bonding between fibre and matrix. It clearly indicates that on addition of nanoclay, progression damage was reduced and the hemispherical impactor failed to penetrate on the back face. Hence, it can be concluded that the nanocomposites samples offer a better protection against penetration than pure epoxy sample. The presence of stiffer nanoclay significantly reduced the surface cracks propagation and controlled delamination area on the back faces of the nanocomposites samples.
