Investigation of Tribological Behaviour Properties in Coated Carbide Tools for Steels Turning Operation

D. Venkatesa Prabu¹, R. Nandhakumar², A. Sathishkumar³, R. Chandiran⁴

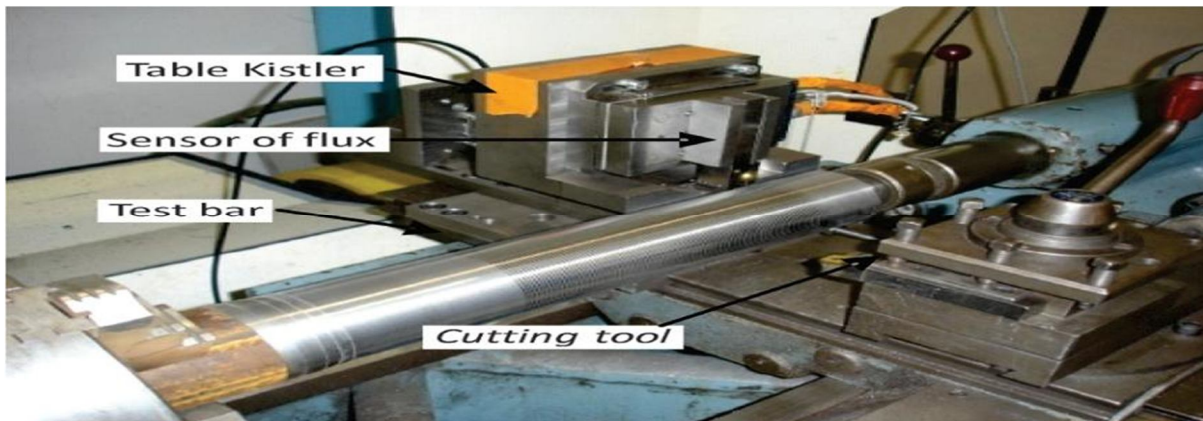
Fig. 1. Cutting test and machining on an instrumented Gazeneuve lathe installation

The tests were performed in the Laboratory of Tribology and System Dynamics (LTDS) Saint Etienne, France, using round bars made of 42CrMo4 and 27MnCr5 steels with 80 mm diameter and 600 mm length with improved machinability. The longitudinal turning and tribological cutting operations (in orthogonal cutting), were performed on conventional lathe (Gazeneuve). The chemical composition of the material to be tested is given in Table 1. The machine being used is Gazeneuve lathe (Figs. 1 and 2), equipped with KISTLER 9257B standard dynamometer with the objective to measure in real time the three force components along x , y , z .

During longitudinal turning and in order to prepare the next test, it is of importance to measure the wear of TiN coated carbide inserts as shown in Fig. 1 and meanwhile searching the interaction between the two forms of wear (flank VB and crater KT) as function of time of cutting. It can be noticed from Fig. 6 that the curves are continuous.

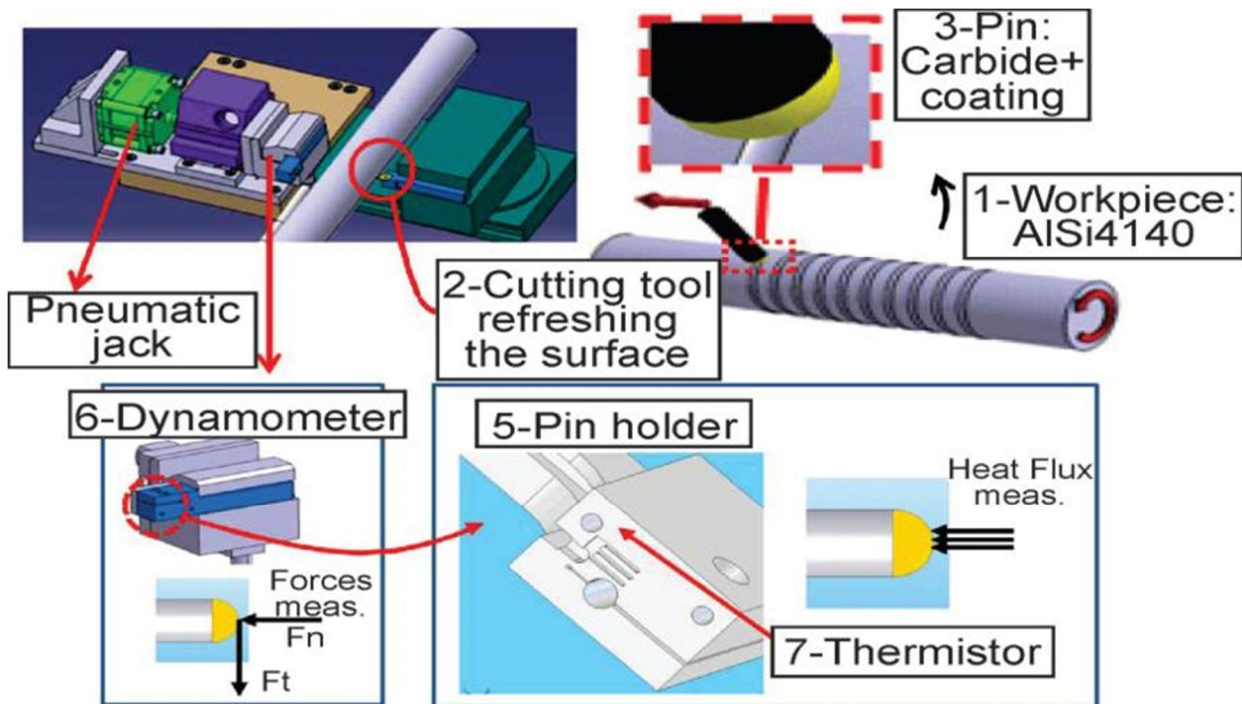
Fig. 2. Measure principles on a tribometer intended to acquire the efforts and the heat flow

An interface for acquisition of heat flow is directly connected to the pin holder whose principle is based on thermistor transducers

(Fig. 2). The tests have been carried out in a dry environment without lubrication. Wear has been investigated taking into consideration the following parameters: feed rate, f , 0.8 mm/rev for cutting and 2 mm/rev for scratching, cut depth, a_p of 2 mm and cutting speed V_c between 20 and 180 m/min.

The test bench can generate furrows along the specimen as shown in (Fig. 2). It has been noticed that the coefficient of friction decreases considerably when increasing the cutting speed. For the TiN pin, the fall is precipitous until a speed of 60 m/min is

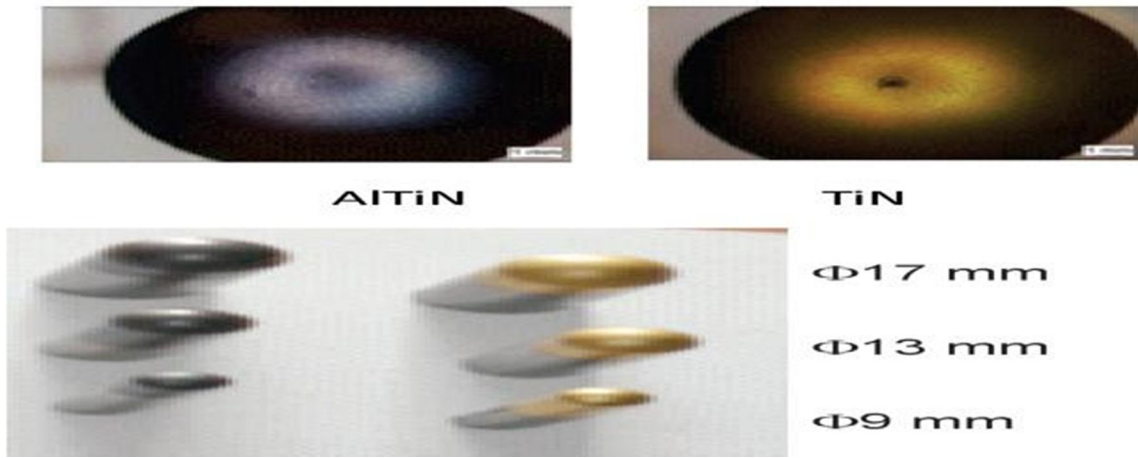
Fig. 3. The different colors of pins coated and their diameter F17, 13 and 9 mm

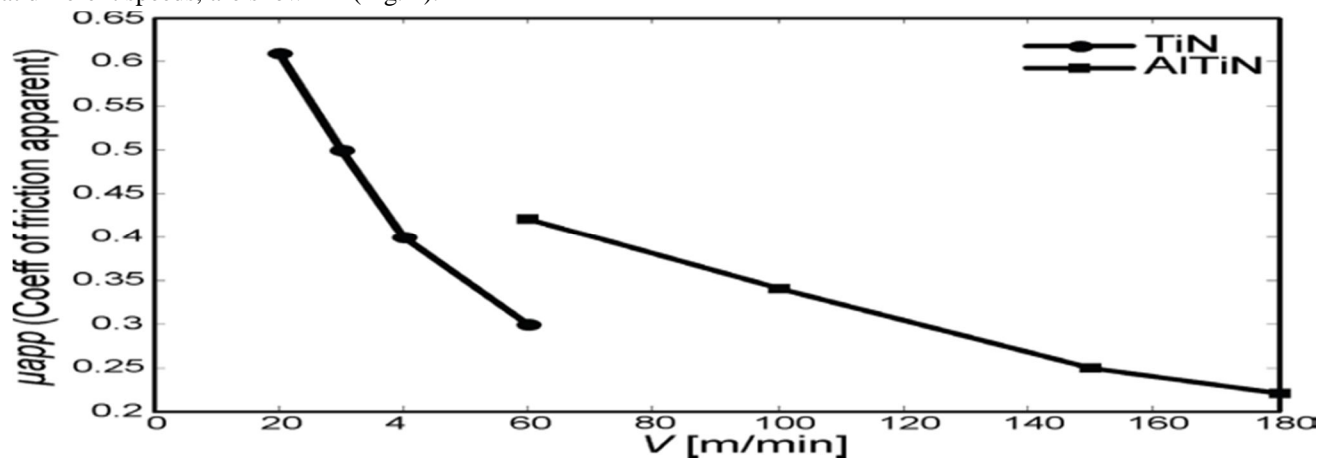
The tribological cutting tests on 42CrMo4 steel with a hardness (HB 290), using TiN and TiAlN pins of diameter 13 obtained by PVD at different speeds, are shown in (Fig. 4).

Fig. 4. Effect of cutting speed on the coefficient of friction

achieved. The AlTiN pin behaves otherwise by falling steadily until 0.23 to a speed of 180 m/min. Here, the apparent friction coefficient which is calculated through the measure of the effort using the following equation, should be mentioned:

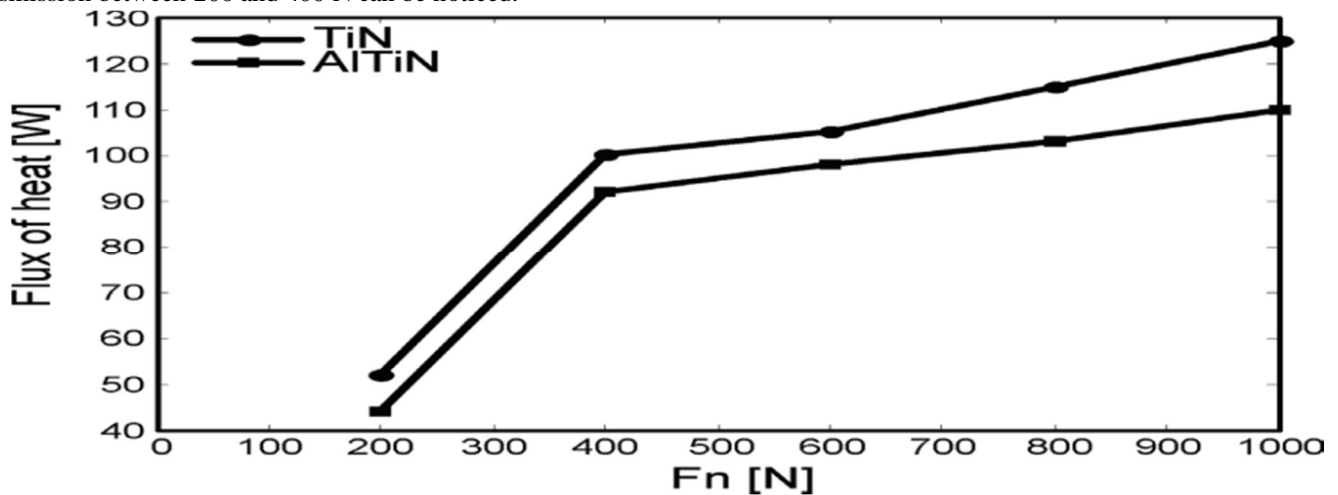
Fig. 5 shows the heat flow evolution transmitted to the pin. Beyond this value, the slope of the flow growth decreases. In fact, and during the contact pin / work piece at a cutting speed of 120 m/min, intense heat is created and increase steadily as the normal stress increases. At 600 N value, the transmitted heat flow to the pin becomes regular and linear. A rapid growth of the heat flow transmission between 200 and 400 N can be noticed.

Fig. 5. Effect of the normal force on the heat flow transmitted to the pin

It is noticed that at 400 N, the appearance of the heat flow changes significantly. This can be explained by the effect of heat diffusion across the pin.

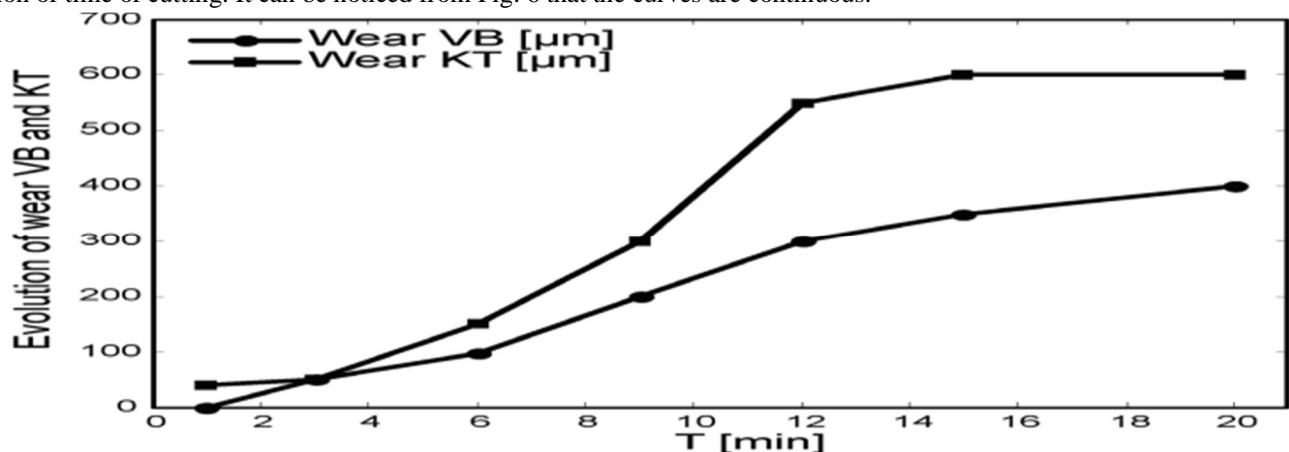
Fig. 6. Evolution of wear VB and KT with time for the cutting speed 150 m/min

After a rapid wear at the beginning of the test, the shape of frontal wear VB becomes almost linear. Beyond 0.4 mm the crater wear rate (KT) increases quickly. For finish operations (following ISO standard ISO 3685-1977 (F) 0.3 mm wear finish and 0.6 mm for draft), which is the case, the flank wear VB which is more representative it is then taken into account. Both wear VB and KT

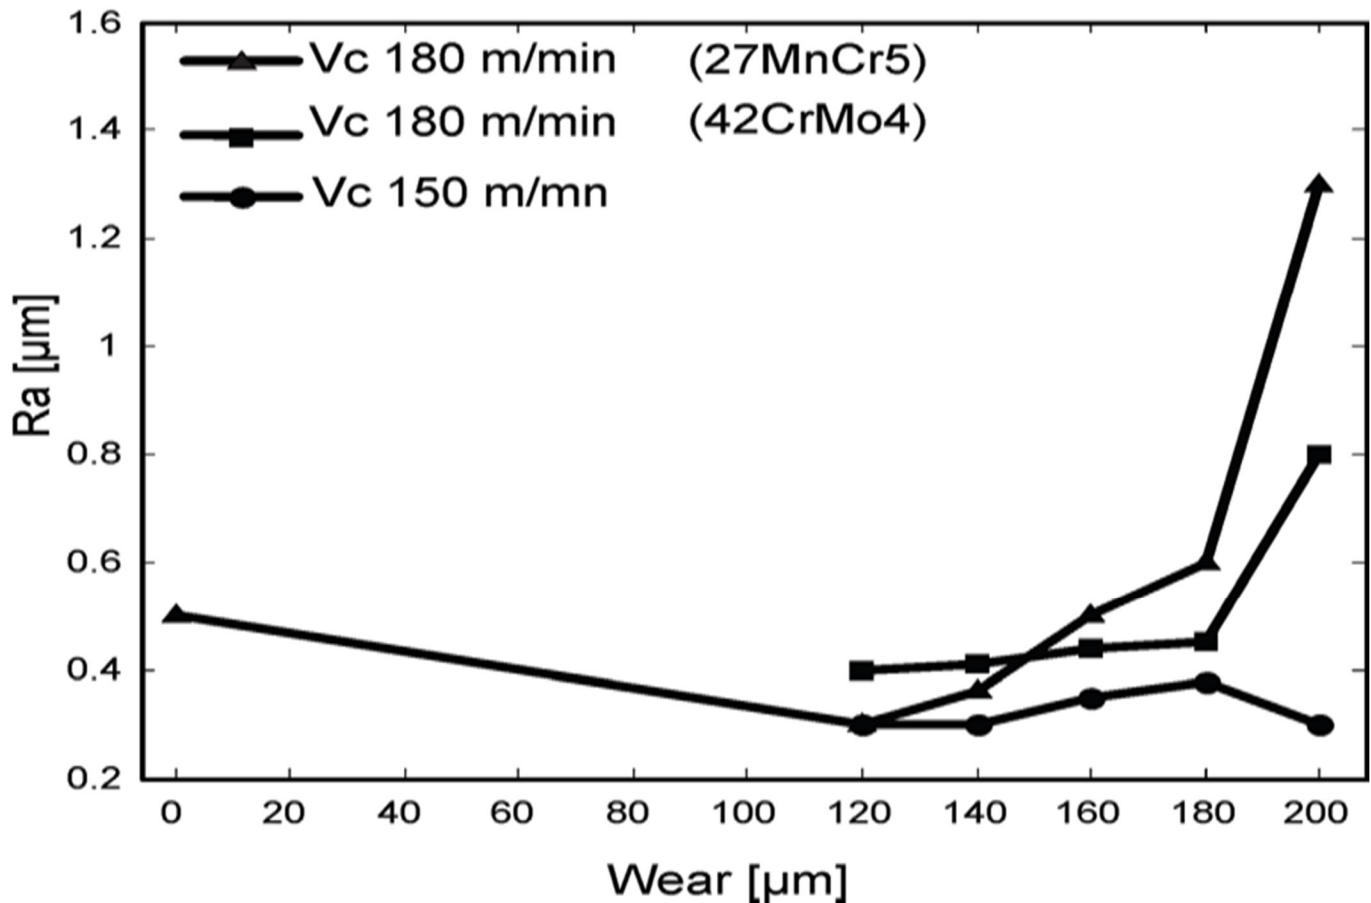
As can be seen from the three curves in Fig.7 and at different speeds, it can be noticed that the surface finish obtained (work piece) with unworn tools is almost regular (near $0.4 \mu\text{m}$). Gradual damage of the surfaces corresponding to the increased wear can also be noticed. In the case where $VB = 300 \mu\text{m}$ is taken as a wear criterion, a significant degradation of the surface which results in an increase in the value of Ra can be noticed. In fact, for fixed upper limit of roughness to $Ra = 0.6 \mu\text{m}$, it has been observed that the lifetime of the plate is significantly reached.

Fig. 7. Roughness Ra as a function of wear VB

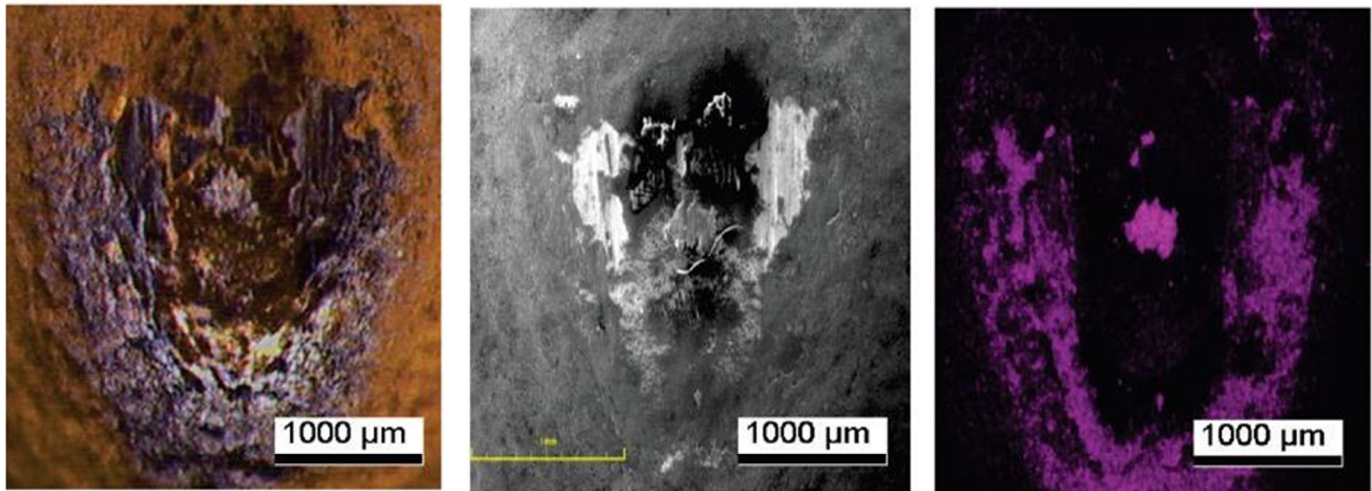
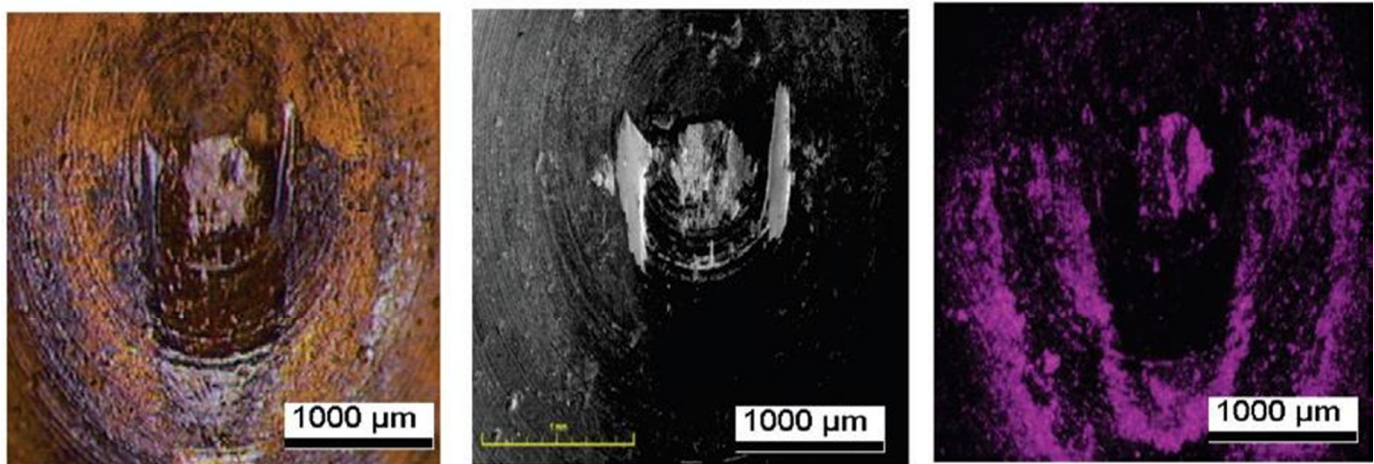
Fig. 8. Observation and analysis of the wear of the pins to after 30 min of different friction types of observation $V_c = 80$ m/min, $f = 2$ mm/rev

The resulting images show the existence of two types of alteration of the coating depending on the type of the material used. The pin being rubbed against 27MnCr5 rods shows an adhesive wear, with a tearing of two plates at the ends of the contact zone. The center of this same zone is protected by adhesive deposits which are shown in black. For the 42CrMo4 material pin, there is a clear presence of two trenches left by the edges of the grooves. Here one can talk about an abrasive wear, since such marks are parallel to the direction of motion. The existence of these two types of wear which are specific to each material is common in the tribological behavior when a couple of materials is used. The adhesive regime often leads to sudden changes of wear which can be due to simple modifications of friction parameters. EDS analyses do not provide further information. Only deposits of the Iron element in the case

of 42CrMo4 confirmed by the density of the alloy, the net propensity to adhere more firmly to the friction surface of the pins compared to 27MnCr5 alloy.

Observation of friction pins allows us to reinforce the assumptions made when interpreting friction measurements. It particularly expresses the respective behavior of materials towards adhesion, diffusion or other tribological phenomena of the contact couple materials (workpiece-pin). At the end of the experimental test, the optical and electronic micrographes of the pin show that the damaged surface is very torn. This is due to severe adhesive wear. This result is confirmed by the adhesion of iron deposits detached from the piece (Fig. 8).

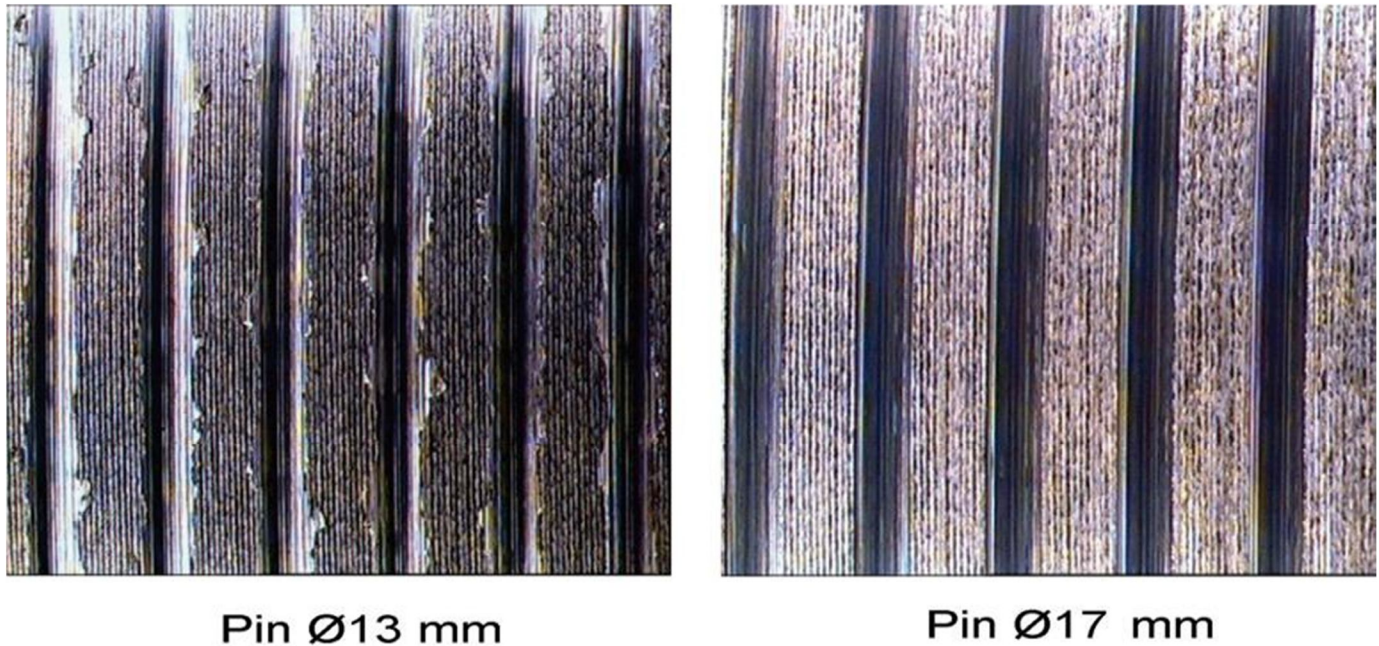
It is well noticed the existence of striations which are parallel to the pin sliding direction, which qualify this kind of wear as soft abrasion wear. This observation seems consistent with the difference between the two materials in contact. In addition, there is a discharge of matter towards the edges of tracks (groove), a sign of ploughing, due to the steel ductility. The observation of the pin at the end of the test very clearly shows a non-uniform wear of the head of the pin.

Fig. 9. Comparison of scratches obtained after scratching using pins Ø13 mm and diameters Ø17 mm; 42CrMo4 - magnification $\times 1$
- $V_c = 80$ m/min

The widths of scratches observed on 27MnCr5 bars remain relatively constant (Fig. 9), during testing. Only those left by the pins in the bars of standard material, increase furthively after the first twenty minutes of friction. This seems to confirm the destabilizing of the recorded coefficients of friction. Therefore, there is a slight difference in behavior on the friction with time between the two alloys. The scratches left in the 27MnCr5 alloy are in fact much larger than those left on of 42CrMo4 alloy (about 1.8 mm) showing a more pronounced wear of the pin associated with the 27MnCr5 alloy (about 1.25 mm). After each friction testing, the used piece is removed from the lathe to take measurements of scratch widths left by the pin on it. Measurements are performed in the middle of the specimen (and therefore at the middle of the experiment). These data will enable us to assess the contact local pressure, to express the densities flow, and to evaluate the speed impact on the sliding conditions of the pin.
